A 500m side channel has been re-connected to the River Spey at Aviemore, enhancing ecology and restoring instream habitats for a multitude of species.

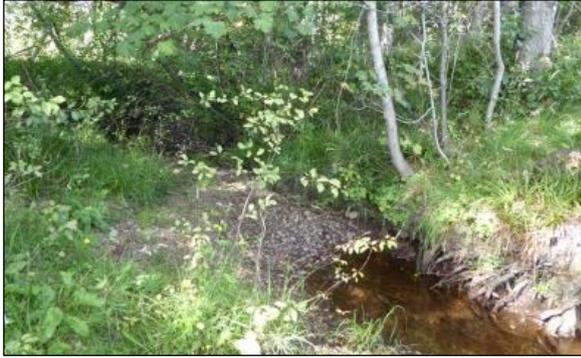
Channel during dry periods (no flow)

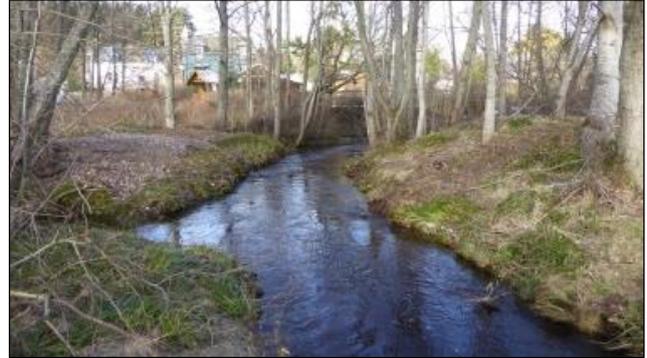
Continuous flow in channel

A culvert was incorporated into the rock armour such that there will now be a constant inflow to the backwater. During larger flow events the River Spey already overtops the existing banks and the opening of the backwater channel will have no significant impact on flood levels or extents. The 500m channel was also cleared of extraneous accumulated debris, but was not dredged or remodelled in any way.

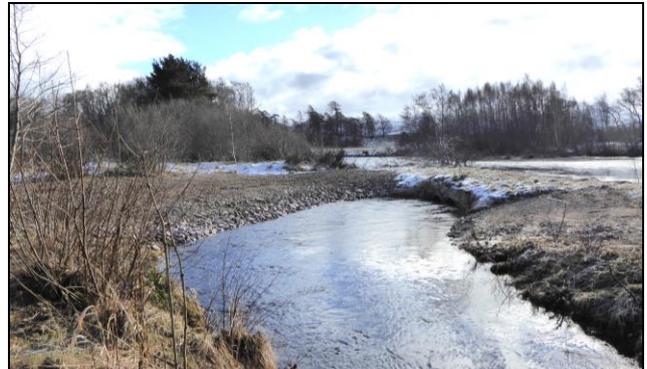
Culvert now installed
